**Ships for Scrap II**

# **Steel and Toxic Wastes for Asia**

**Worker health & safety and environmental  
problems at the Chang Jiang Ship-Breaking Yard  
operated by the China National Shipbreaking  
Corporation in Xiangyang near Jiangyin**

November 1999

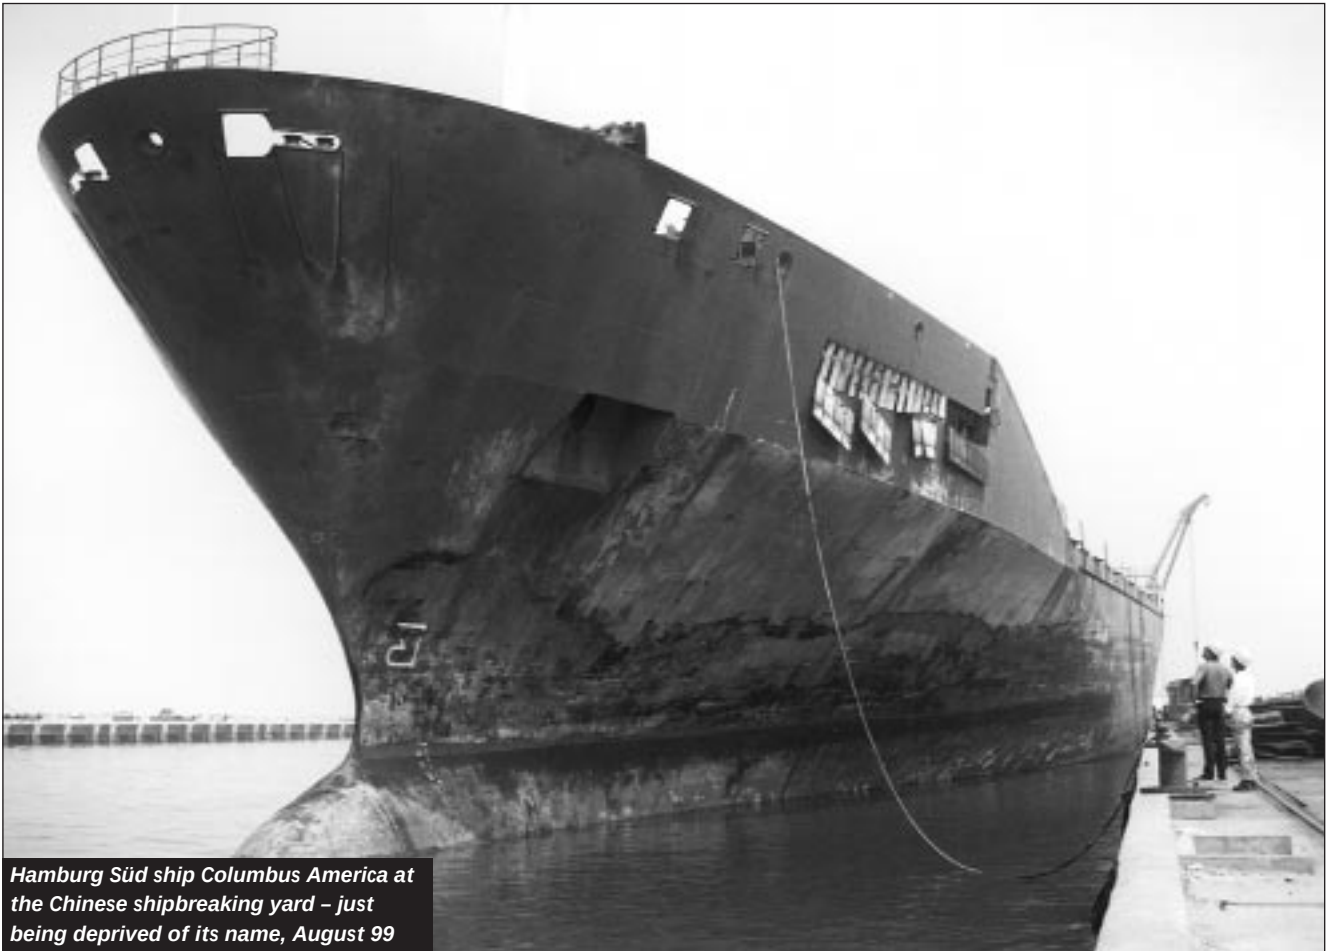
*Hamburg Süd ship Columbus America at the Chinese shipbreaking yard – just being deprived of its name, August 99*

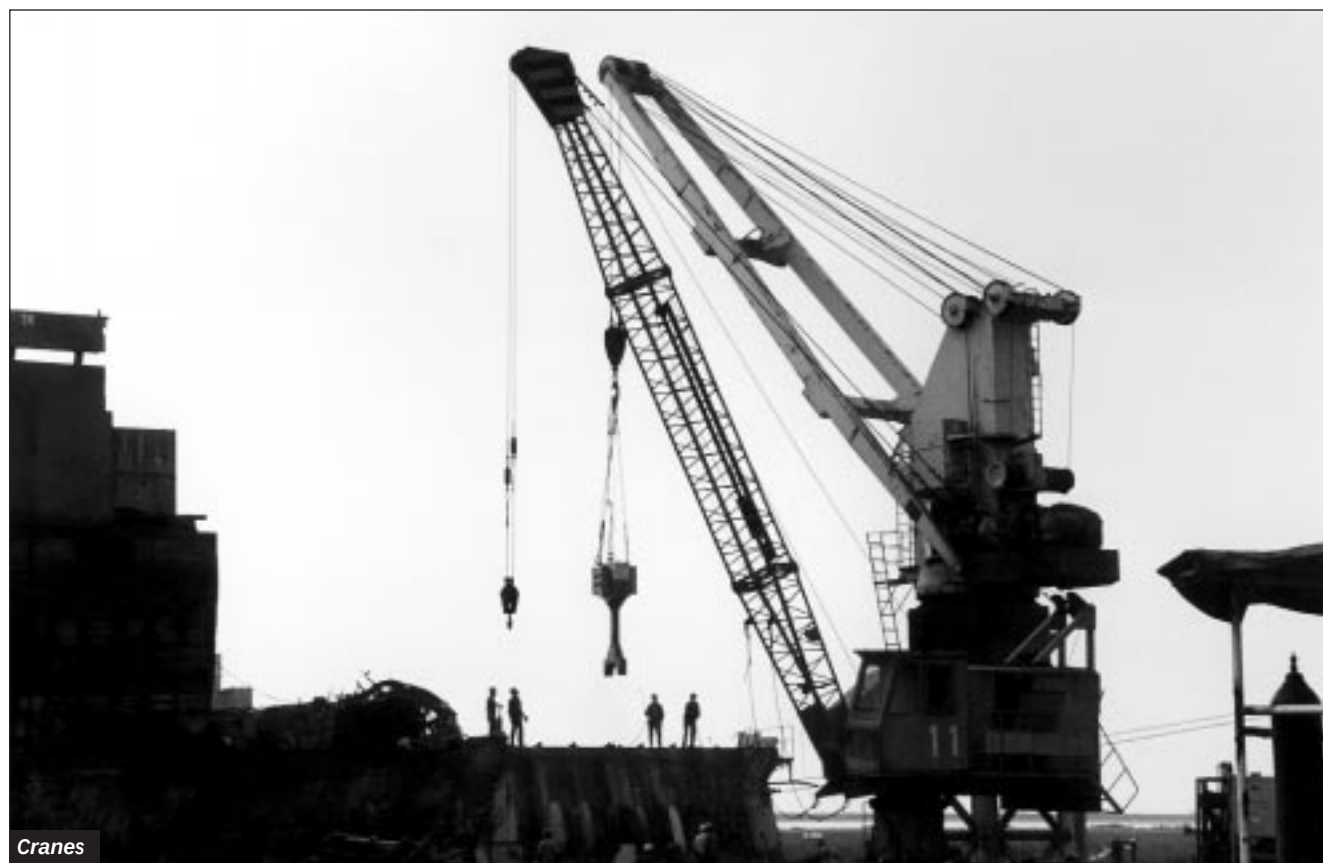
Cranes

The infrastructure of the yard consists of a pier at which the ships dock, and cranes by which heavy parts are lifted ashore or onto river barges for transport to steelworks.

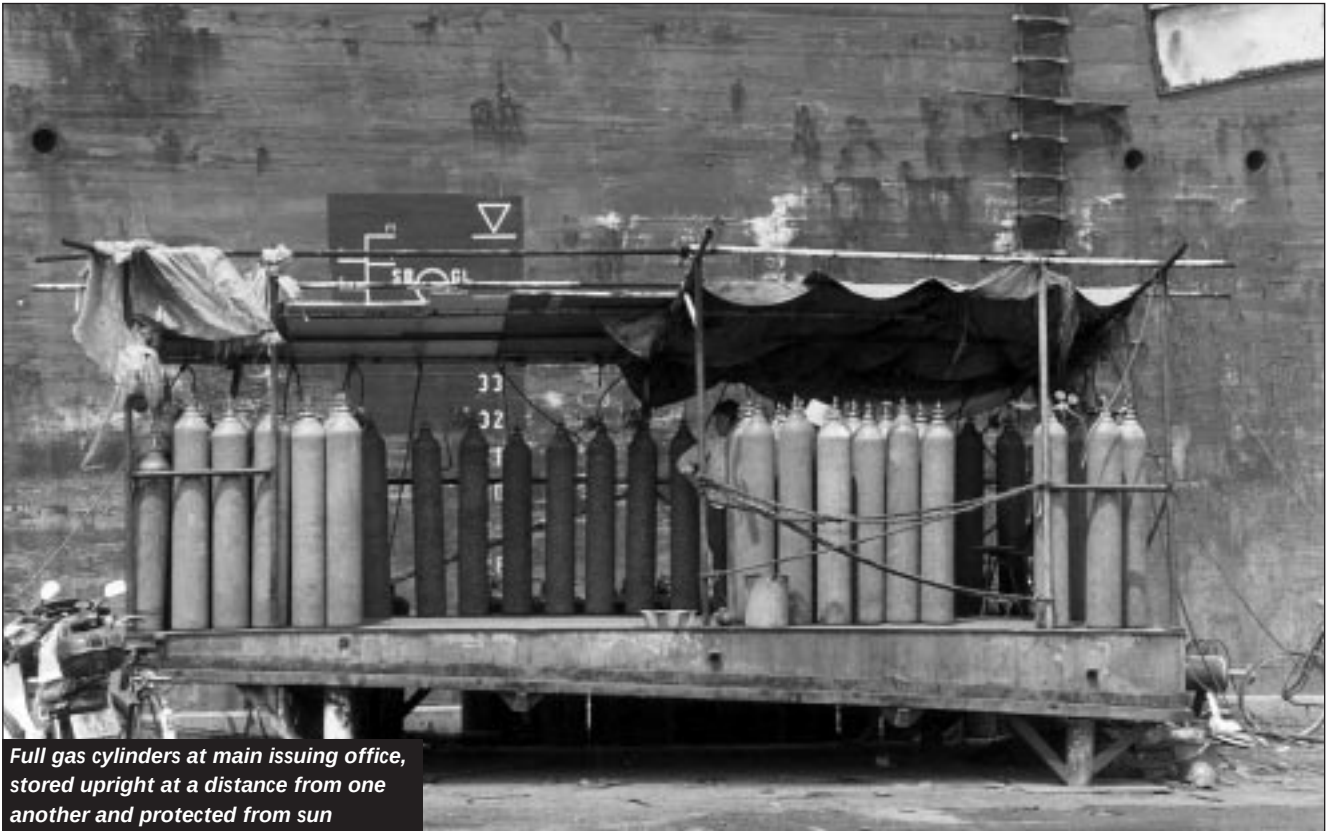
*Full gas cylinders at main issuing office, stored upright at a distance from one another and protected from sun*

Dismantling work is carried out on paved areas. Here smaller transport vehicles operate, such as fork-lift trucks. Full gas cylinders are stored carefully, with gaps maintained between cylinders, standing upright and under protection from the sun. Cylinders are administered by a central issuing point.

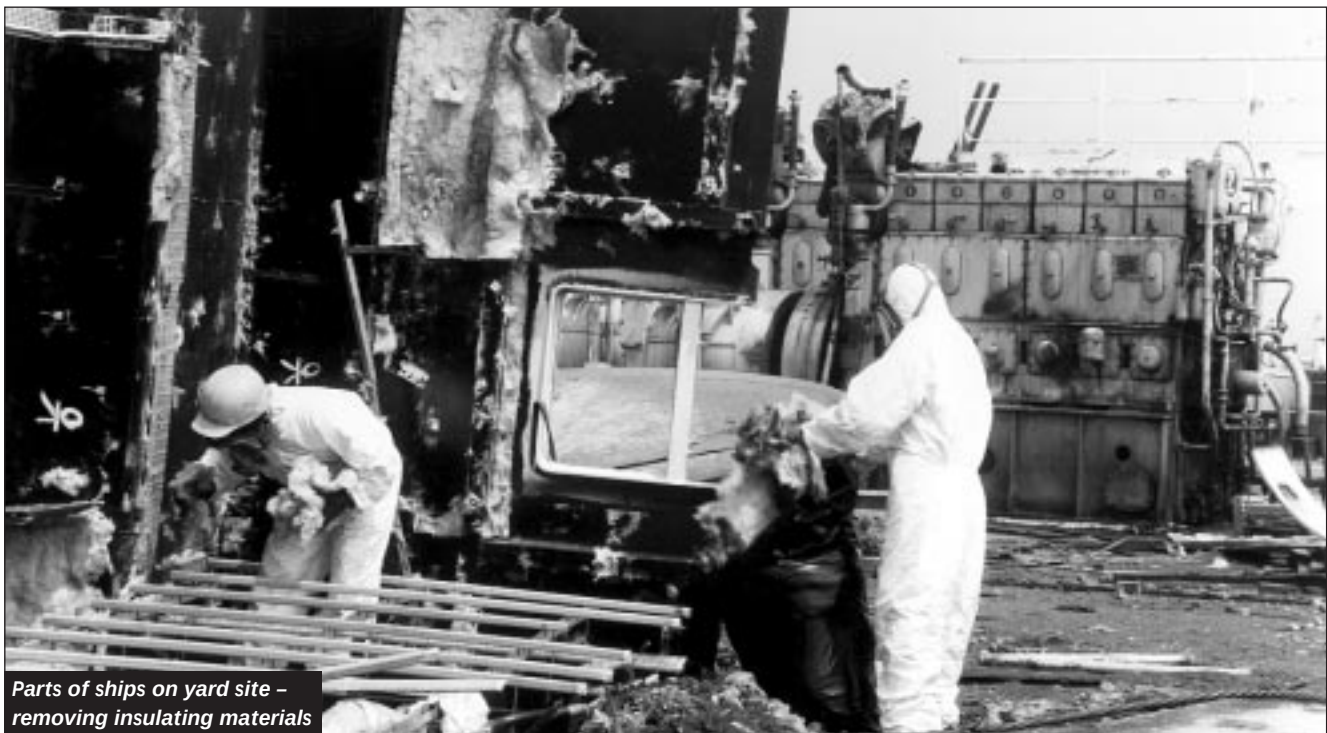
Workers clad in whole-body protective clothing extracted manually (with suitable gloves) all insulation materials that could contain asbestos, packed them into plastic sacks, emptied these onto a tip and fetched new loads using the same sacks. Fully packed sacks of this material stood around unclosed. The collection rate may figure around 90%. The remainder is strewn around the yard.

Parts of ships on yard site – removing insulating materials

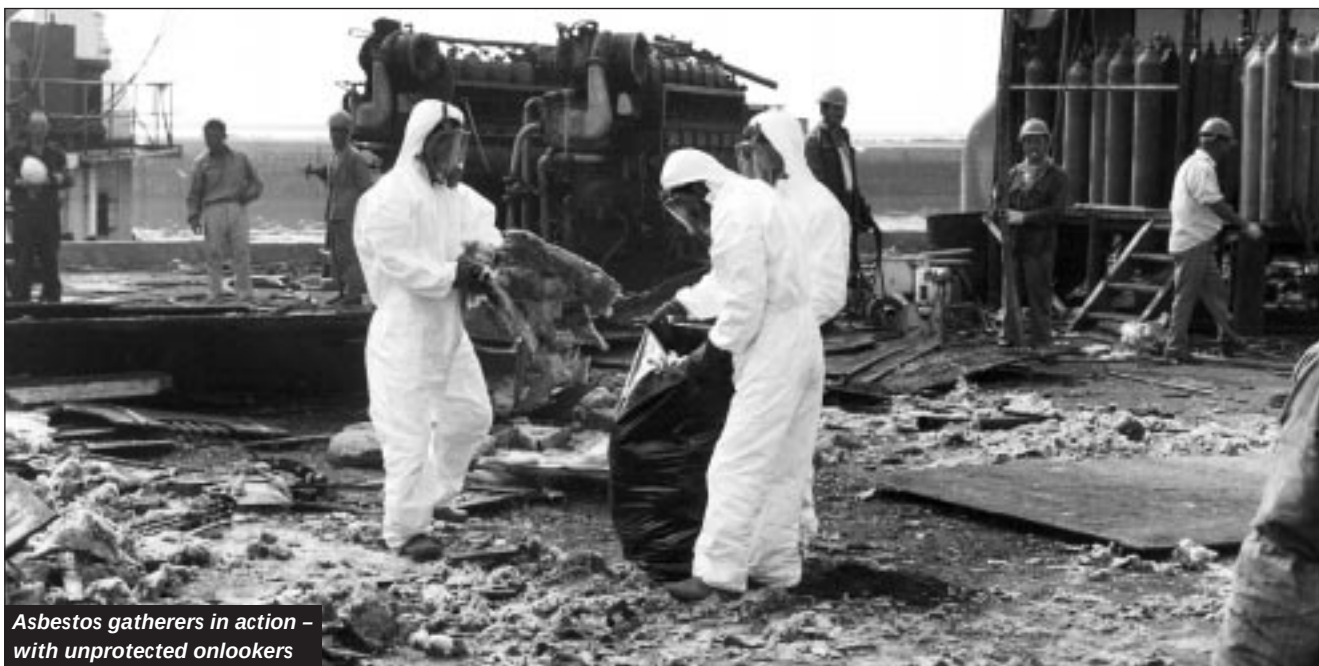
The working zones of the asbestos collectors were not separated from or marked off against those of other workers. Even visitors were admitted to inspect operations close up without any protection.

**Asbestos gatherers in action –  
with unprotected onlookers**

The protective suits had been supplied by the Hamburg Süd shipping group, which had insisted upon their use. The workers made an untrained impression. At times, they opened their protective masks during work, and in no way refrained from handling the materials directly next to other, unprotected workers. The absurd picture of a group of workers fully clad in protective clothing amidst completely unprotected people gave us the impression that the asbestos problem is not taken seriously, and is perhaps not even really known. The Chinese worker health & safety regulations handed to us made no mention whatsoever of asbestos.

Asbestos is recognized as a hazardous material of the first order. We therefore recommend training a special team for handling asbestos-containing materials, similar to the firefighting team already set up at the yard according to the documents given to us.

Whole-body protective clothing should already be mandatory for workers fetching asbestos-containing materials from the ship. Critical areas need to be made moist before work begins, in

order to suppress dust formation. Areas in which asbestos-containing parts are stored, dismantled and processed must be separated and sealed off.

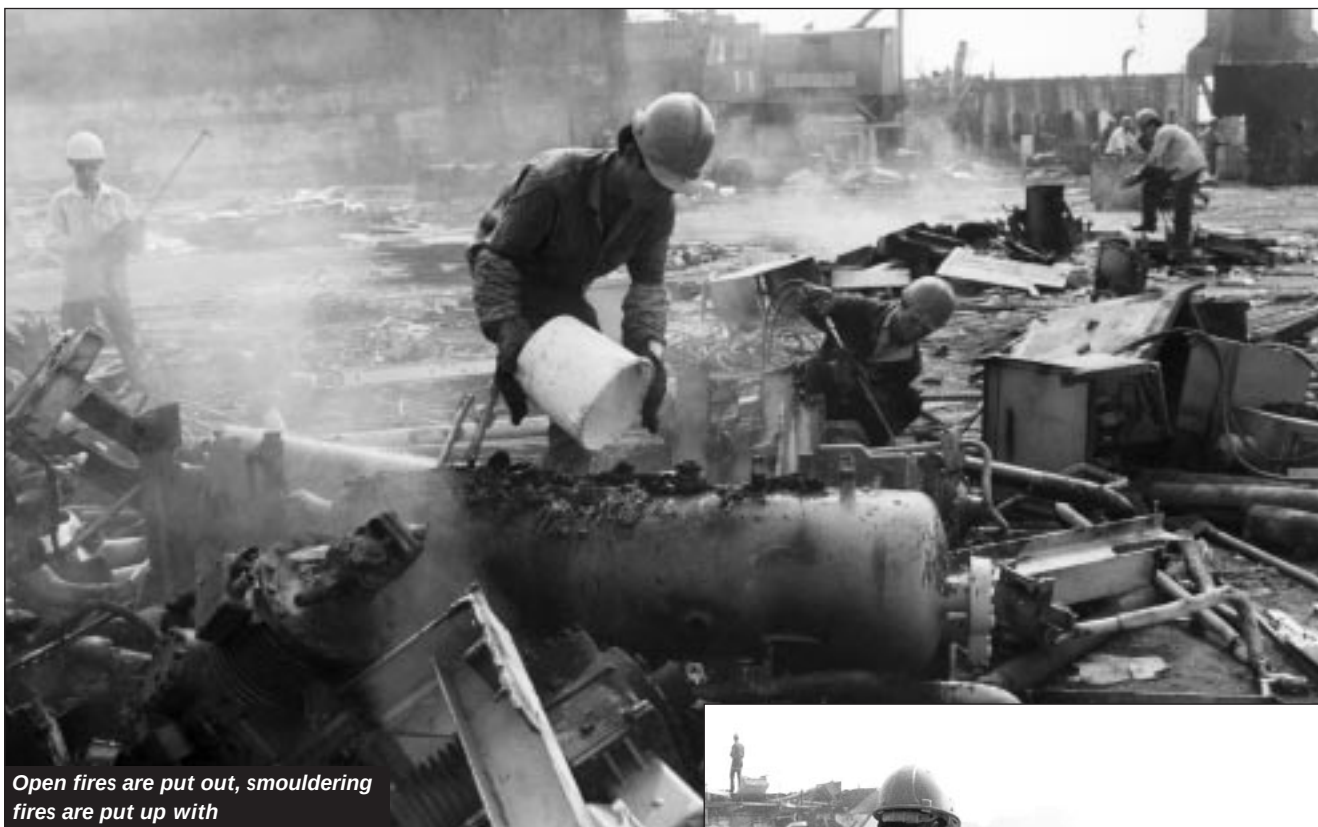
*Open fires are put out, smouldering fires are put up with*

At the yard, open fires were put out swiftly with water, but small smouldering fires were left uncontrolled.

- Withdraw materials, i.e. remove all inflammable objects and oil residues rapidly from the yard and consign these either to recycling or, where that is not possible, to controlled landfill.

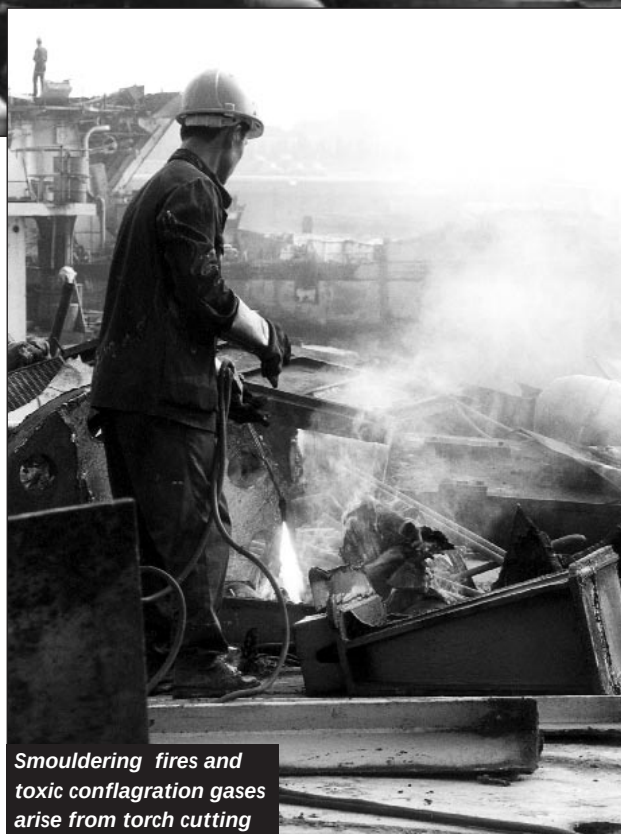
The workers using the cutting torches are exposed inescapably to toxic vapours (PAHs) and falling ash containing heavy metals. These substances contaminate the entire working area and its surroundings.

*Smouldering fires and toxic conflagration gases arise from torch cutting*

- Prepare the steel by mechanical removal of paint along the cutting line by means of sandblasting or scrubbing.
- Use protective goggles and, where necessary and certainly in poorly ventilated interiors, breathing apparatus for workers.

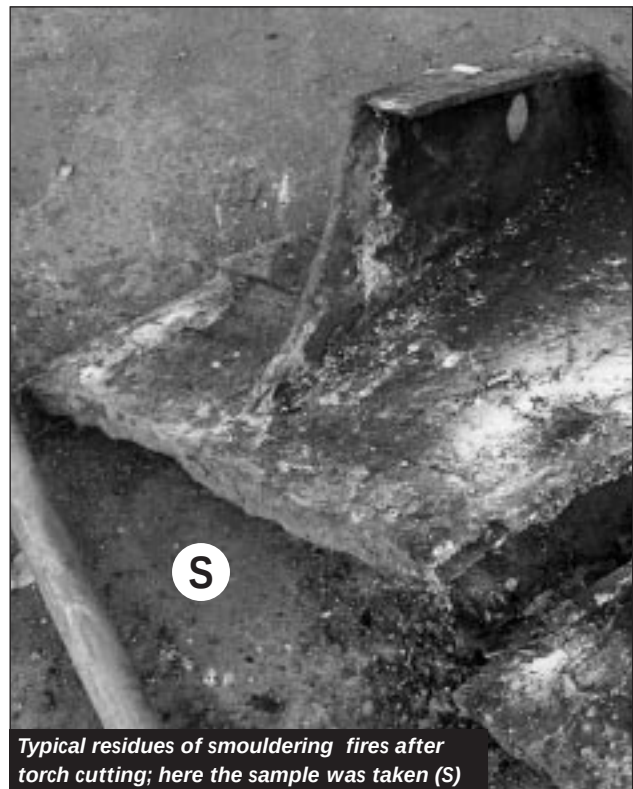
Analysis of a sample taken from the workplace of the cutters found it to contain: Arsenic: 65 mg/kg; Lead: 390 mg/kg; Cadmium: 0.3 mg/kg; Chromium: 282 mg/kg. (6)

The extremely high levels of polycyclic aromatic hydrocarbons (PAH) found in the same dust sample are alarming: 1500 mg/kg (ppm)

Typical residues of smouldering fires after torch cutting; here the sample was taken (S)

The prime concern is to prevent all kinds of fires. Where this fails, fire residues need to be handled and disposed of as hazardous waste in order to prevent further contaminant accumulation at the workplace.

Regular analyses of dust samples taken from the yard should be undertaken in order to gain an indication of whether and where clean-up measures are necessary.

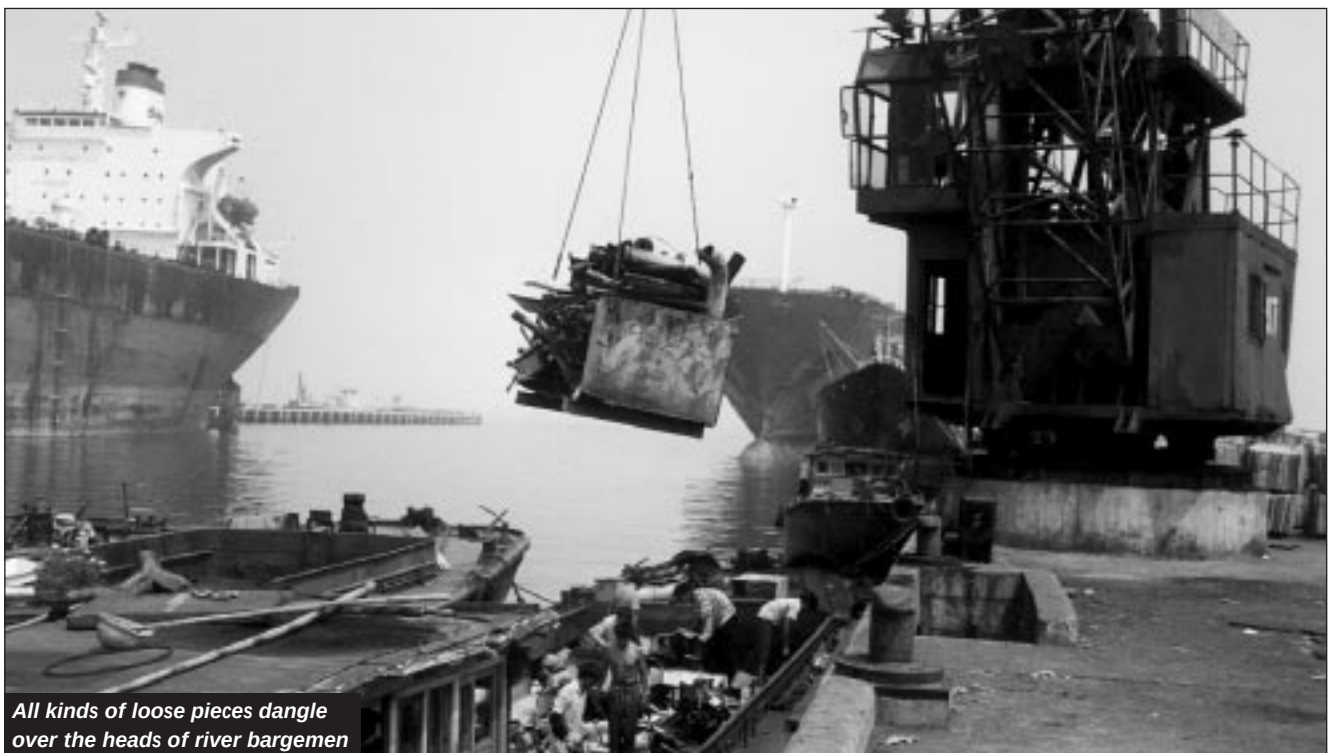
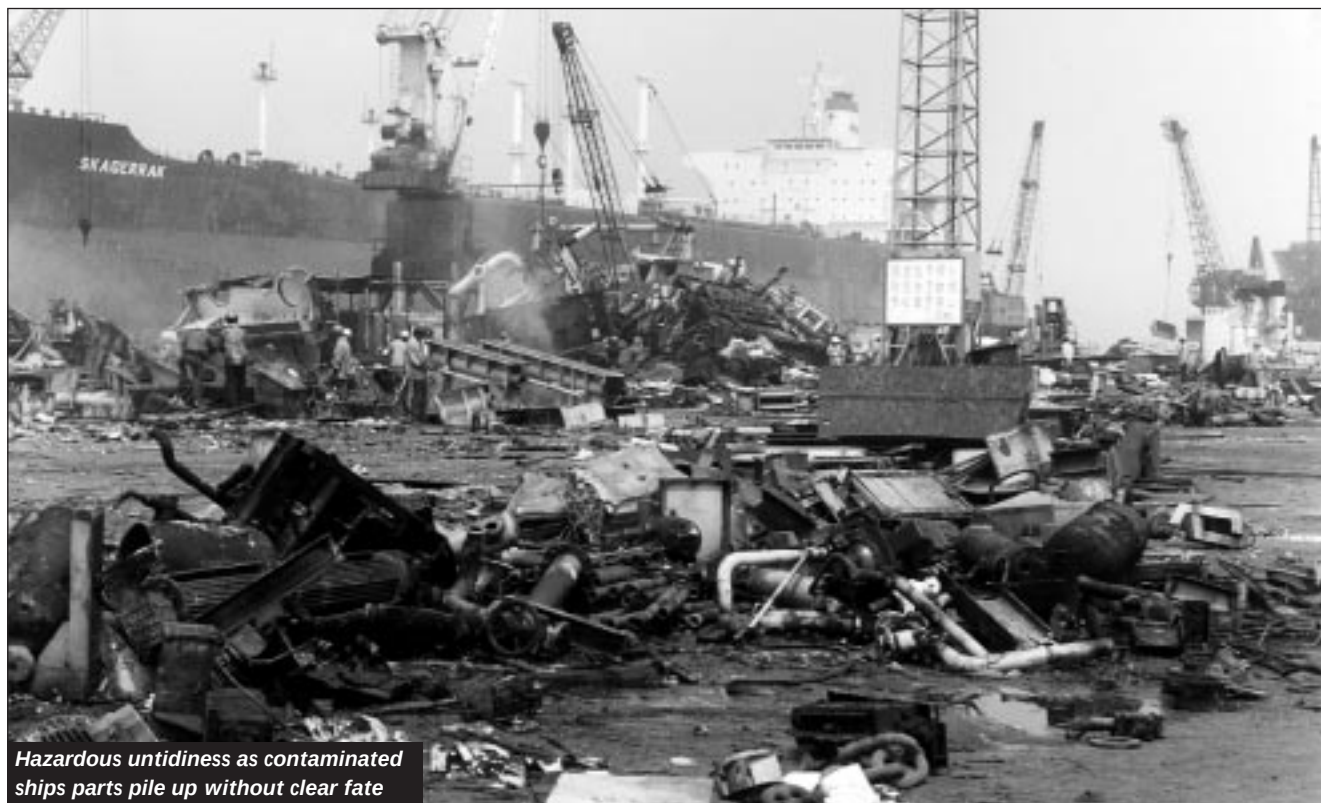
Many parts of ships are cut mechanically and then cold-rolled. However, many other parts are smelted in blast furnaces. This can generate

emissions problems. For this stage of the process, yard management and company management should cooperate with steelworks operators and the environmental authorities to find solutions

relating to furnace technology and flue gas management and control in steelworks.
